Recreational Use Attainability Analysis for Buffalo Creek (0214B), Paradise Creek (0230A), and Sweetwater Creek (0299A) in the Red River Basin

DRAFT for PUBLIC REVIEW

Prepared for:
Texas State Soil and Water Conservation Board
Project 12-52

TR 1308

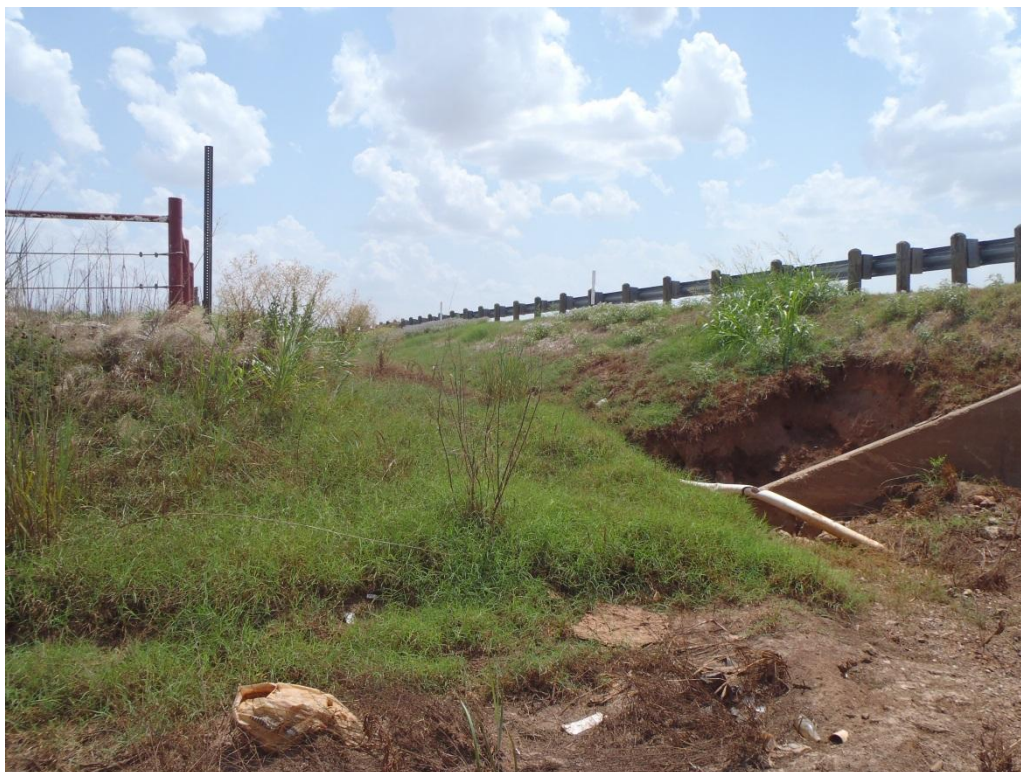
This site was surveyed on June 9 and August 11, 2013. Access was public at the bridge and continued downstream approximately 150 m before a private property fence restricted further access (Figure 4.15). Stream bank access was moderately easy at the bridge and traveling through this portion of the creek was also moderately easy, however banks were steep for the majority of the 300-m survey (Table 4.6).

Figure 4.15 Photograph of PD005 taken August 11, 2013 of public access point at the Hwy 183 bridge.

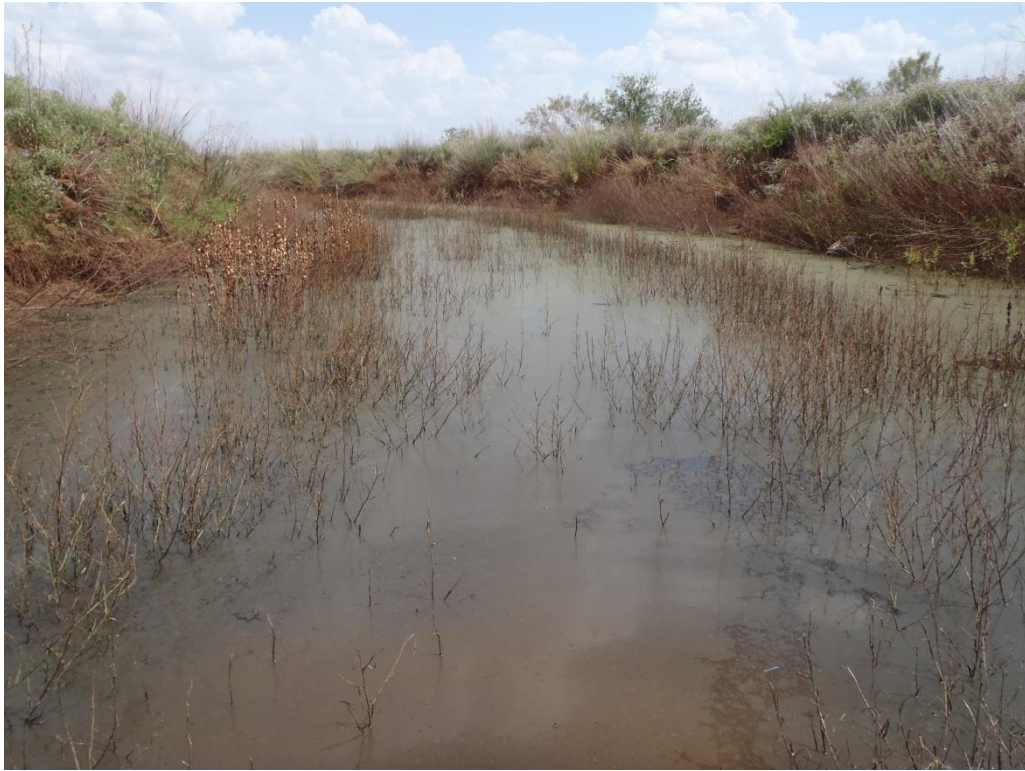
The dominant substrate at this site was fine sediment. The water encountered during the second survey had a scum on the surface and was a brown color (Figure 4.16). Algae cover was also present during the second survey. The banks were vegetated with pasture beyond the riparian area on both the right and left sides of the stream (Table 4.5 and Figure 4.17). Vegetation at the bridge was slightly more dense and dominated by salt cedars (Figure 4.18).

Figure 4.16 Photograph of PD005 taken on August 11, 2013. Downstream 300-m transect. Note the surface scum.

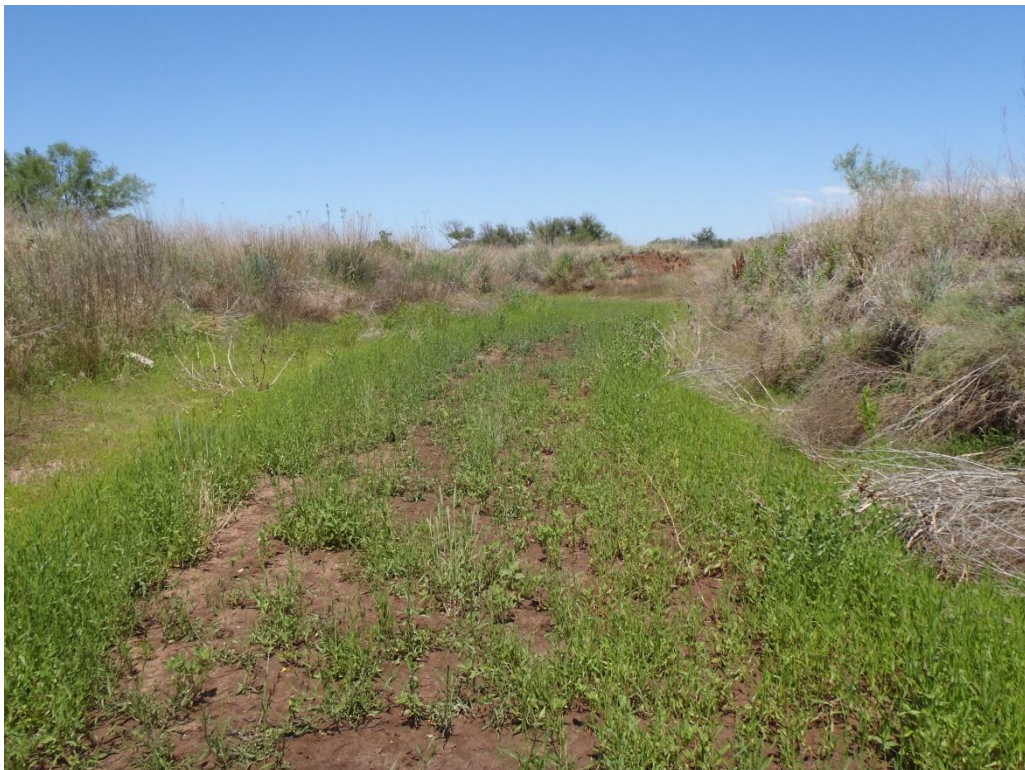
Figure 4.17 Photograph of PD005 taken on June 9, 2013. Upstream view of the 30-m transect.

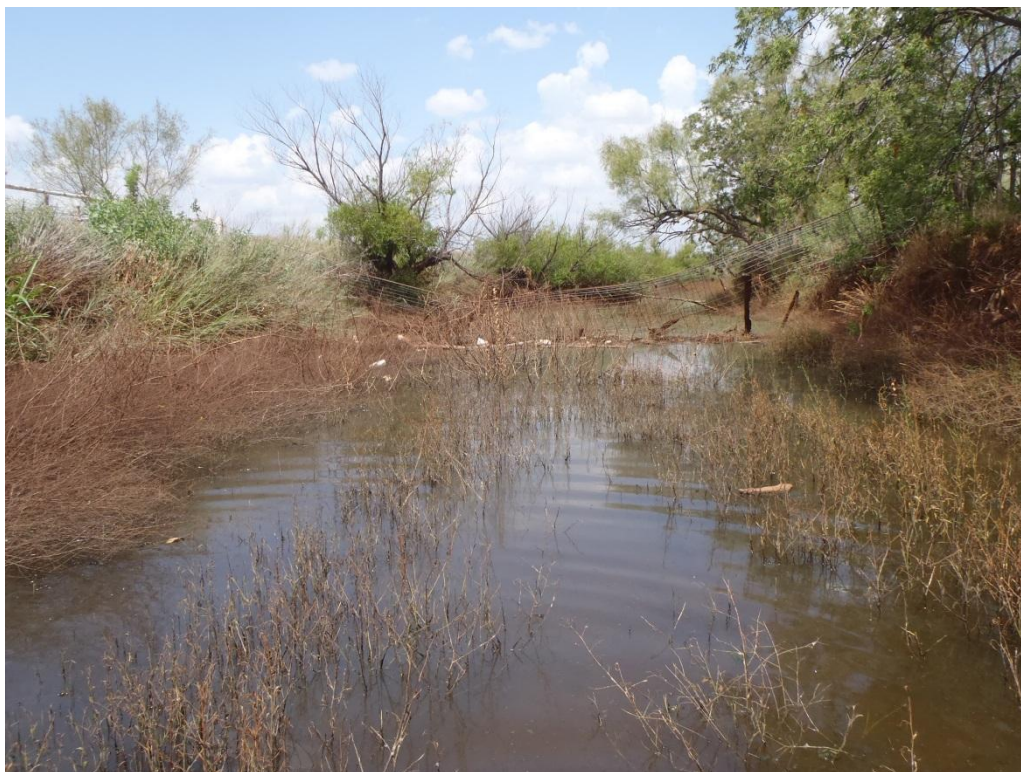
Figure 4.18 Photograph of PD005 taken on August 11, 2013. Downstream view at the 150-m transect. Note the steep, vegetated banks, water gap and presence of water.

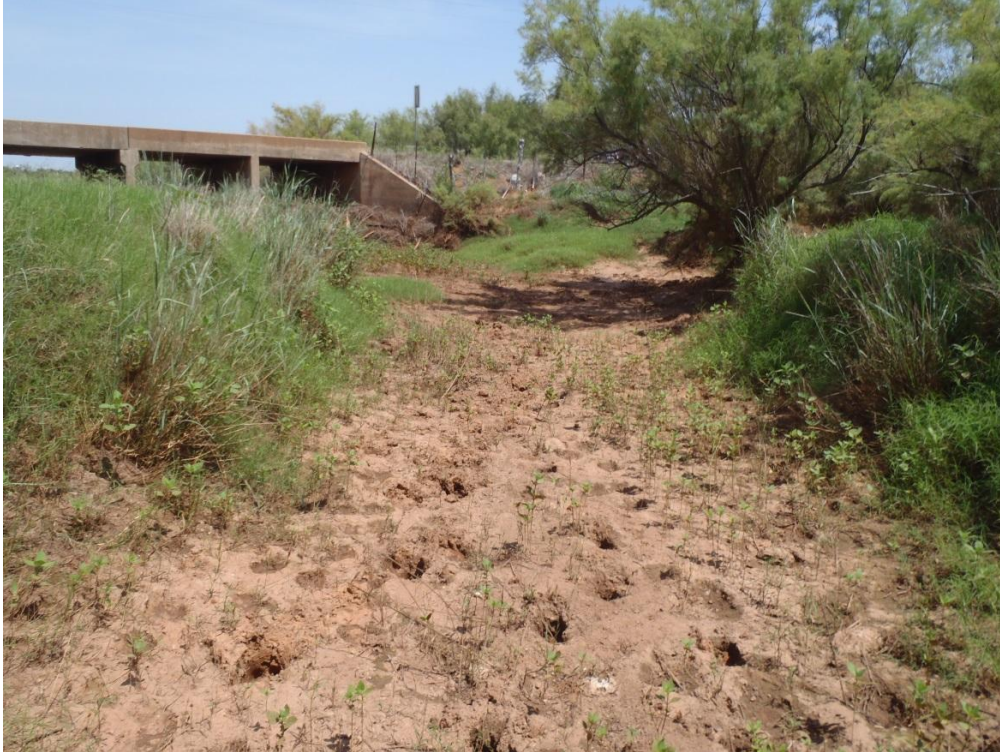
PD006 was surveyed on June 9 and August 13, 2013. Access to this site was moderately easy as it was located at the County Road 128 bridge. However, entering the stream at this site is only publically accessible from the bridge itself. A private property fence comes up and meets the bridge then restricts further stream access as it bisects the creek as well (Table 4.6 and Figure 4.19). Traveling the creek was also moderately easy as it had little to no water and was relatively free of dense vegetation or debris. A large debris pile had accumulated at the bridge between surveys but did not cause a hindrance for the second survey (Figure 4.20).

Figure 4.19 Photograph of PD006 taken on August 11, 2013. Downstream view of the 30-m transect. Note private fence connecting with the bridge, hindering public access.

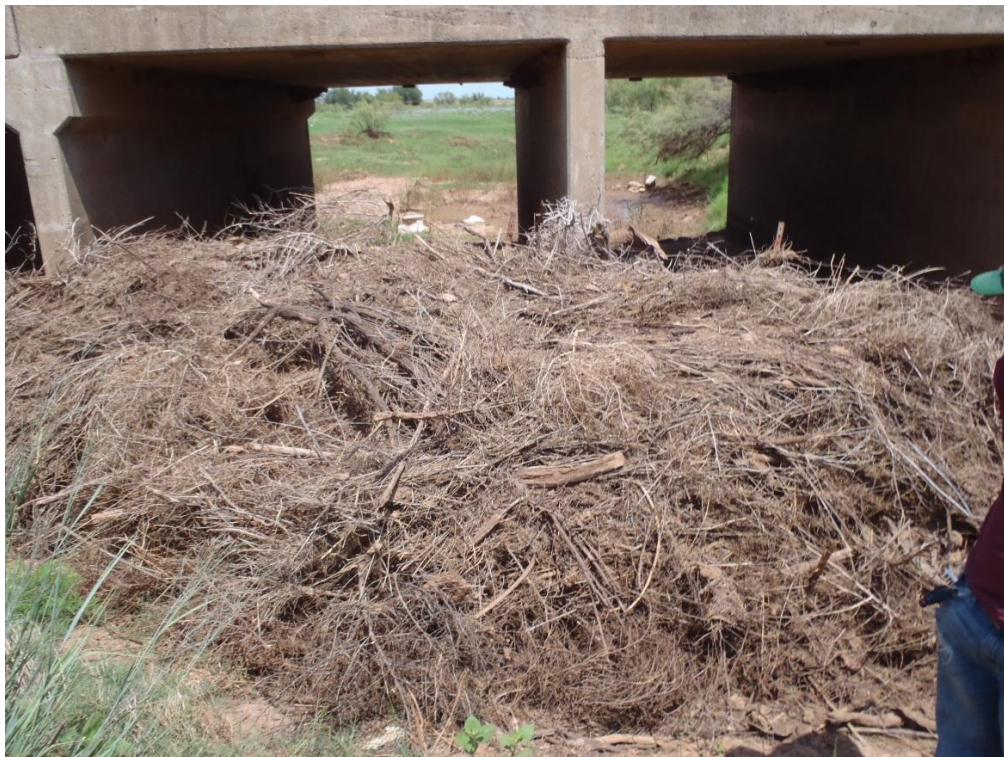
Figure 4.20 Photograph of PD006 taken on August 11, 2013 of the debris accumulation at the bridge. TIAER personnel in photograph.

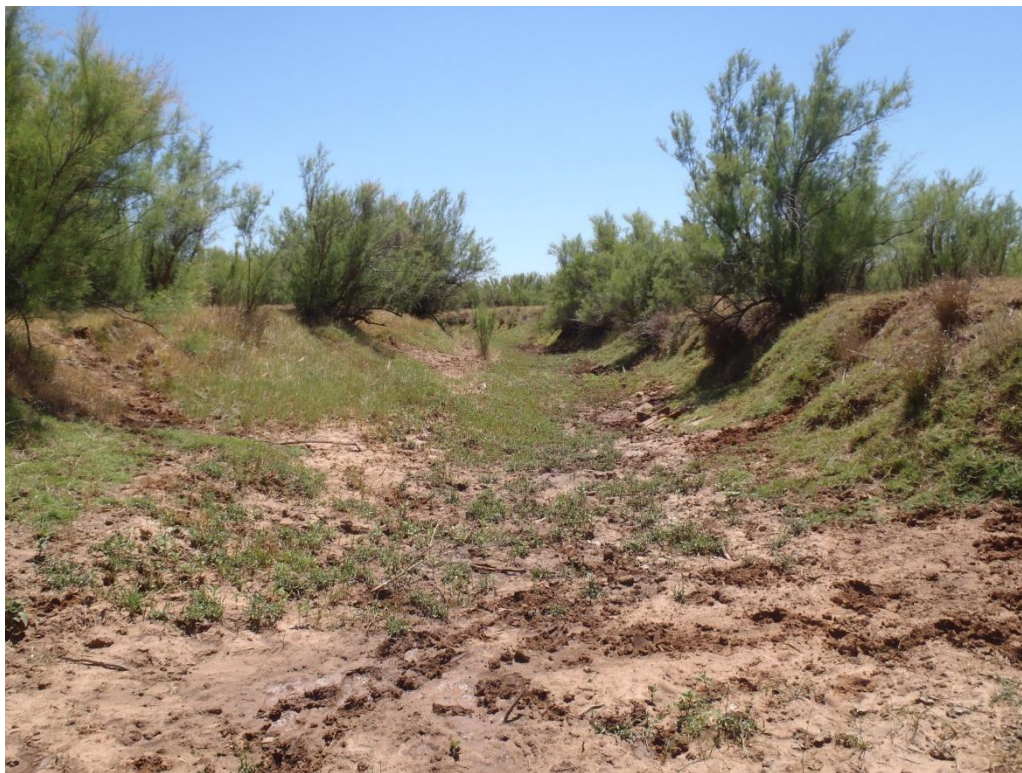
Primary substrate was fine sediment that turned to mud/clay when wet (Table 4.5). During the second survey when water was present, the water surface was clear with a brown color (Tables 4.9 and 4.10). The banks were gently sloping with some livestock trails leading out and the dominant vegetation type in the corridor was salt cedar shrub land (Figure 4.21).

Figure 4.21 Photograph of PD006 taken on June 9, 2013. Upstream view of the 300-m transect. Note gentle sloping banks, lack of water and shrub dominated corridor.

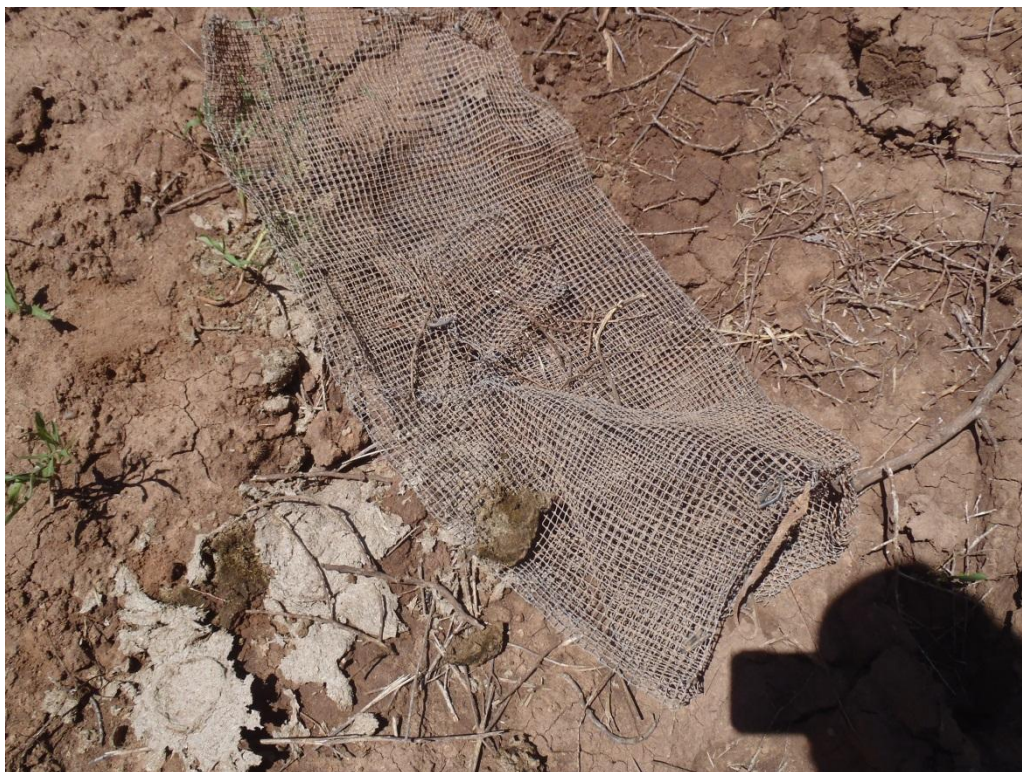
Evidence of wildlife presence included frogs, and tracks of deer, turkey, raccoon, and evidence of beaver activity in the form of a gnawed tree stump. Cow manure and tracks were also seen in the creek. Garbage was rare at this site but did include the carcass of a dog at the bridge along with some sheet metal, glass bottles and aluminum cans and discarded outdoor furniture at the bridge. (Tables 4.9 and 4.10). A crushed minnow trap was also observed in the creek (Figure 4.22). No other evidence of human recreation was observed.

Figure 4.22 Photograph of PD006 taken on June 9, 2013 of a crushed minnow trap.

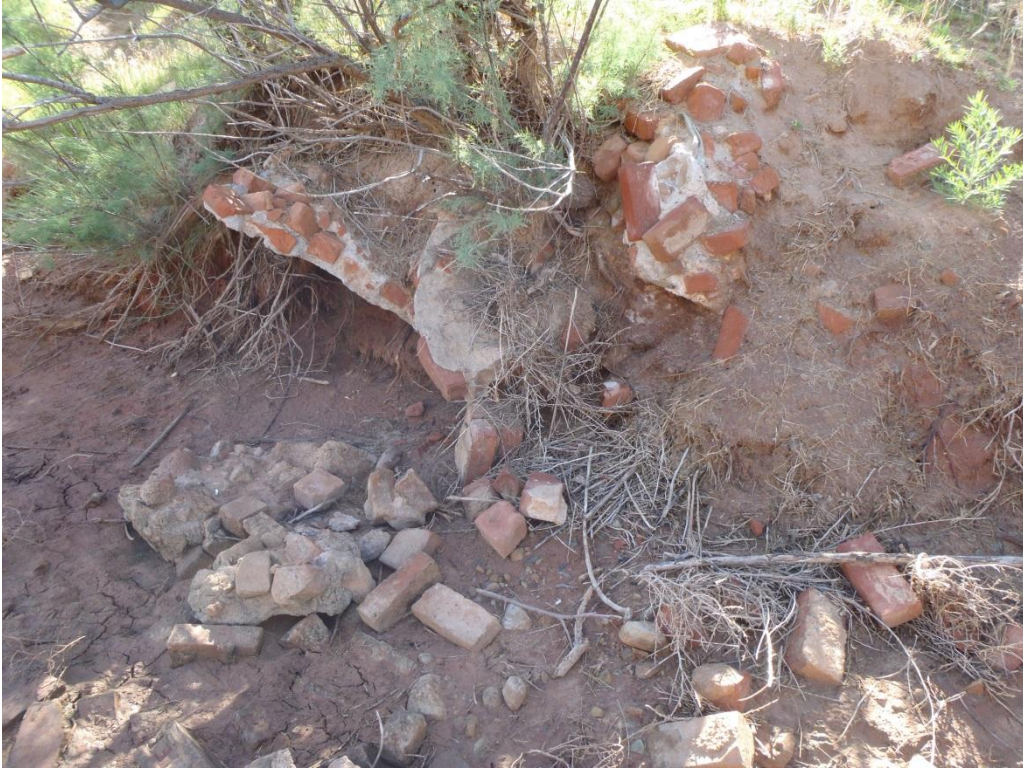
Garbage was rare at this site. Concrete debris, rebar and some irrigation pipe was seen at the washed out bridge transect (Figure 4.23). Along the stretch a few glass bottles were noted. Approximately half way through the 300-m stretch, debris of bricks fused with concrete and rebar were observed on the bank and down the bank into the channel (Figure 4.24). At the 300-m transect, plastic duck decoys were observed floating in the water (Figure 4.25). No other evidence of human recreation was observed.

Figure 4.24 Photograph of PD007 taken June 10, 2013 of brick and concrete on the bank and in the stream.

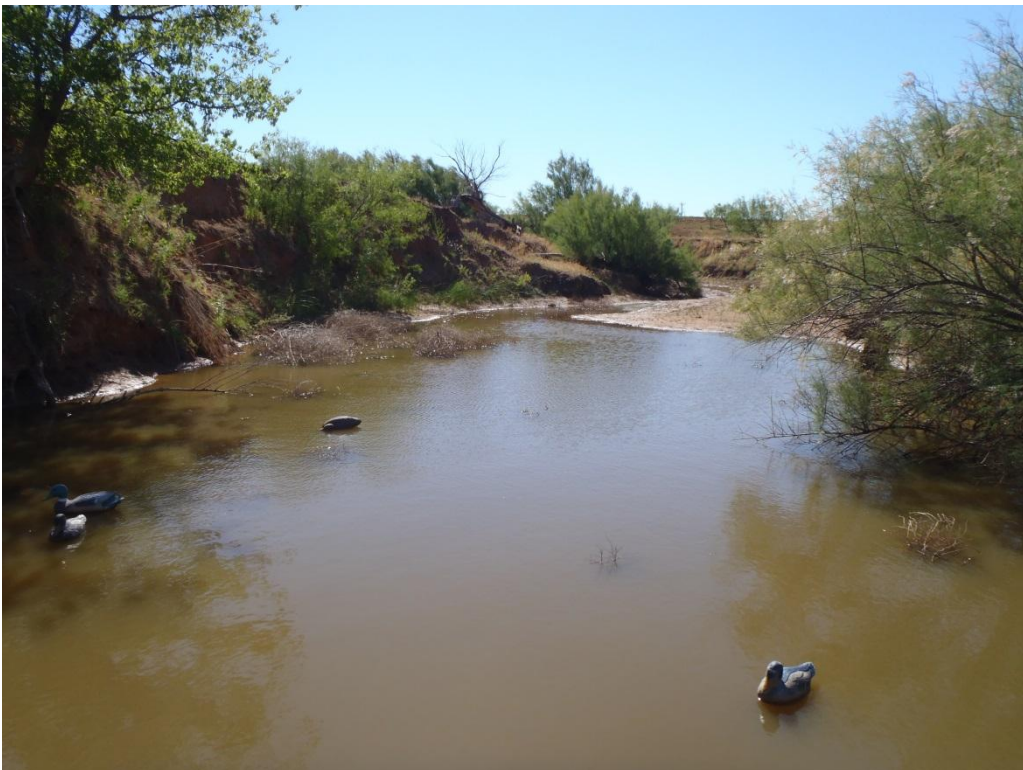
Figure 4.25 Photograph of PD007 taken June 10, 2013. Downstream view at the 300-m transect. Note the pool, duck decoys and steep, shrubby banks.

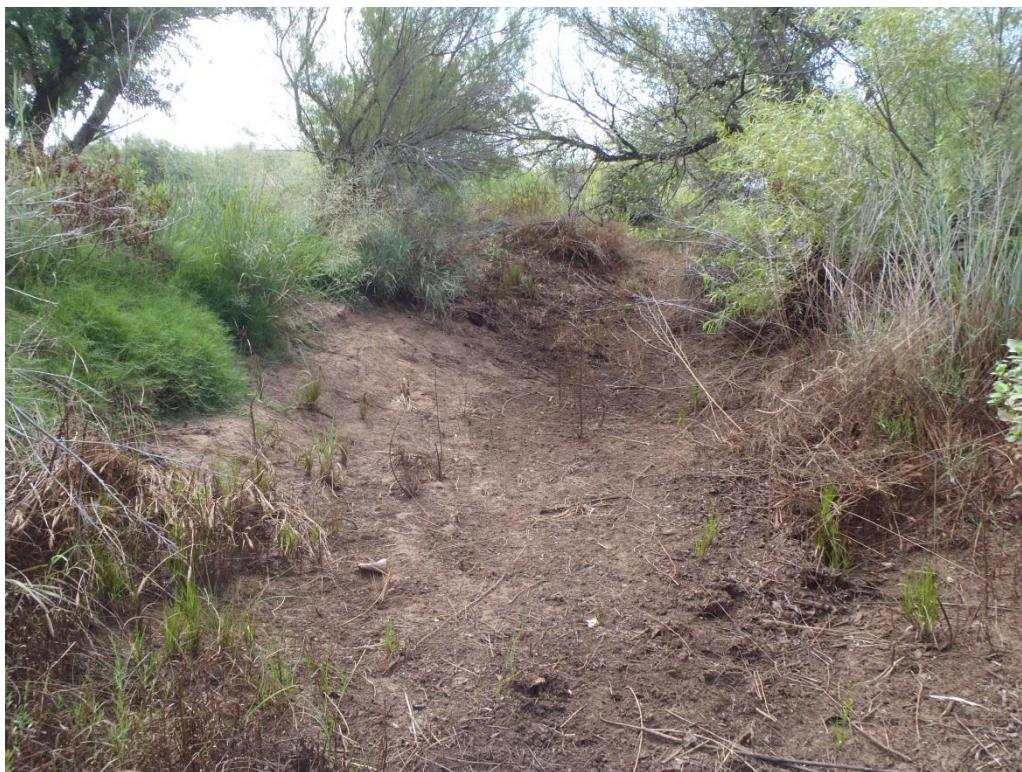
Figure 4.26 Photograph of PD008 taken August 12, 2013. Upstream view at the 30-m transect. Note the open pastureland beyond riparian area and relative ease of access.

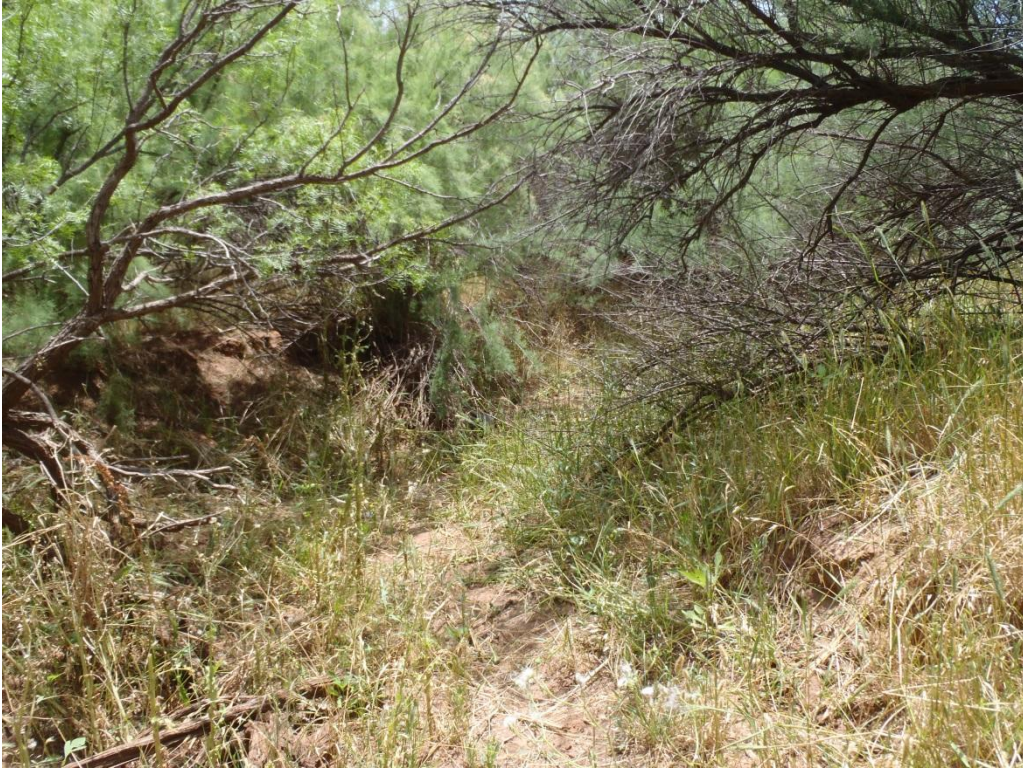
Figure 4.27 Photograph of PD008 taken June 14, 2013. Upstream view of the 150-m transect. Note the dense vegetation.

Vegetation for approximately the first and last thirds of the stretch was primarily pasture with a few trees along the bank (Figure 4.28). The middle third of the stretch was dominated by more dense salt cedar vegetation. A rudimentary man-made dam was observed at the 30-m transect.

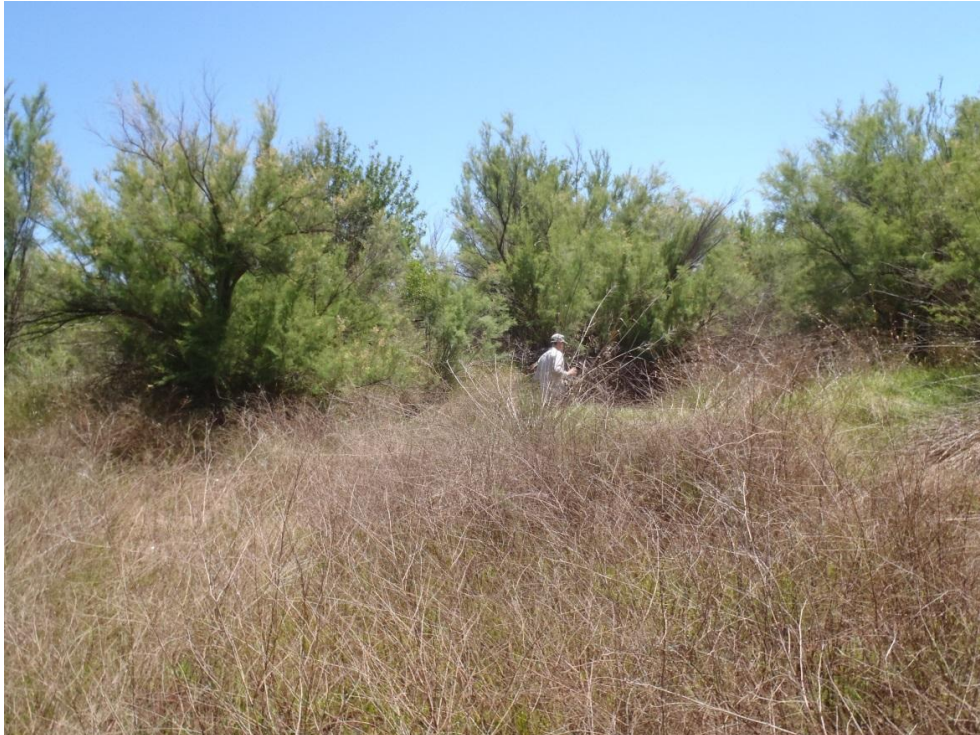
This site was surveyed on June 9 and August 11, 2013. This site was accessible from the bridge and the highway right-of-way. However a private property sign was posted and landowner permission was attained prior to entering the property on the creek (Figure 4.30). Travel to and through this site was moderately easy although dense vegetation did make walking a challenge (Table 4.6 and Figure 4.31).

Figure 4.31 Photograph of PD009 taken on June 6, 2013. Downstream view at the 30-m transect. Note thick vegetation and brush on the banks. TIAER personnel in photograph.

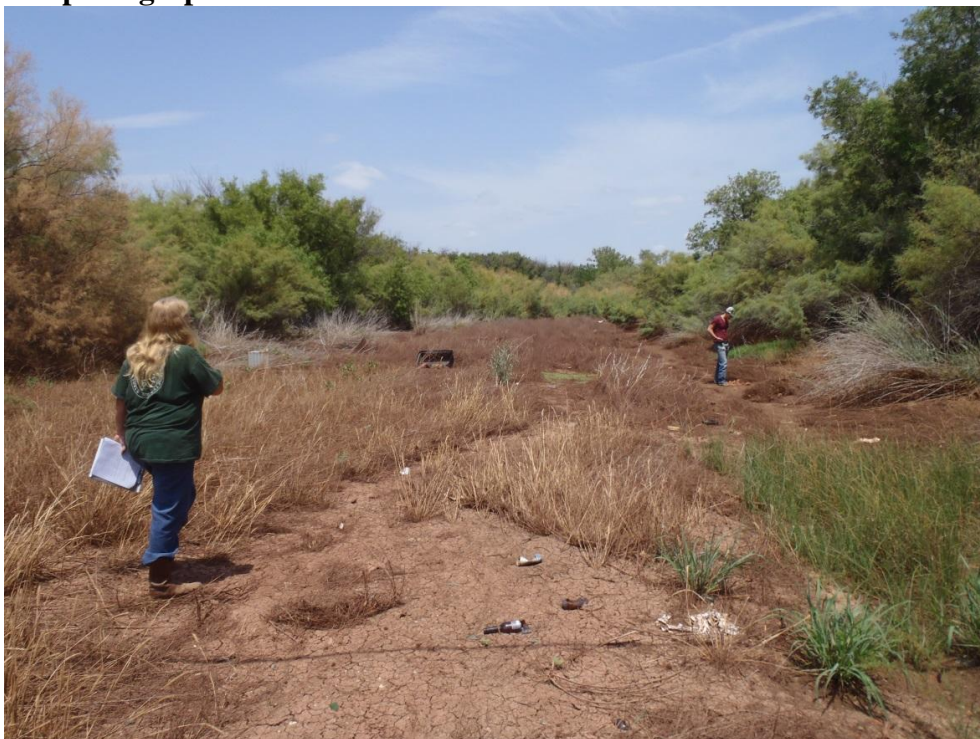
Figure 4.32 Downstream view of the 300-m transect at Site PD009 taken August 11, 2013. Note lack of water and scattered garbage in the channel. TIAER personnel in photograph.

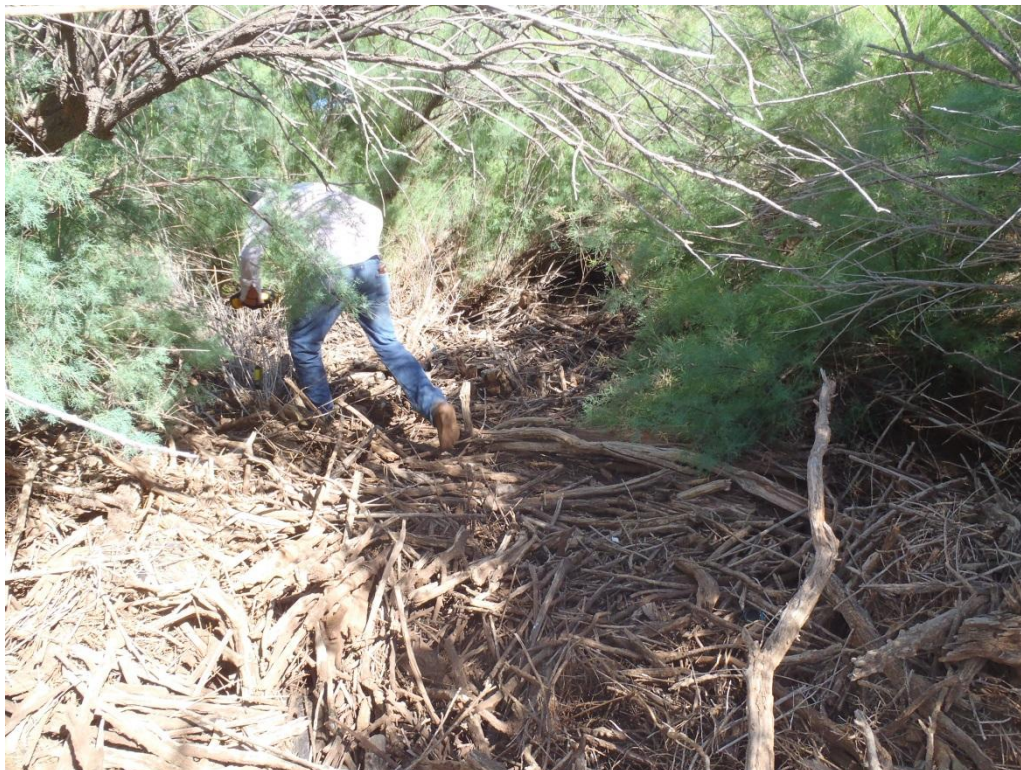
This site was surveyed on June 10 and August 12, 2013. Access to this site was on private property. Access into the channel during both surveys was moderately easy although excessive herbaceous vegetation was noted during the second survey (Table 4.6). A log obstruction and cross fence was observed in the channel that hindered travel in the creek (Figure 4.33), as well as a private property sign similar to the one shown in Figure 4.30.

Figure 4.33 Photograph of PD010 taken June 9, 2013. Downstream view at the 300-m transect. Note log obstruction. TIAER personnel in photograph.

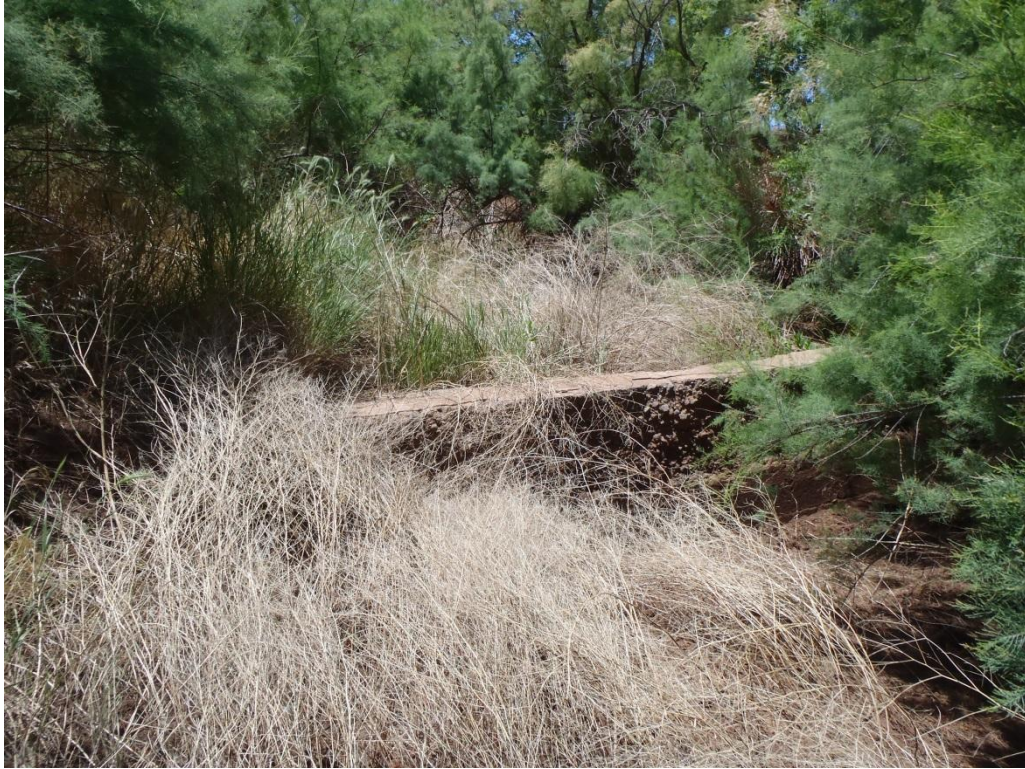
This segment of the Paradise Creek was dry with an average thalweg of 0.00 m during both surveys (Tables 4.6, 4.7 and 4.8). No water was observed in the stream nor measured. A man-made stone dam was observed at approximately at the 45-m transect (Figure 4.35).

Figure 4.35 Photograph of PD011 taken June 9, 2013. Upstream view of the 30-m transect. Note the dense vegetation and the stone dam.

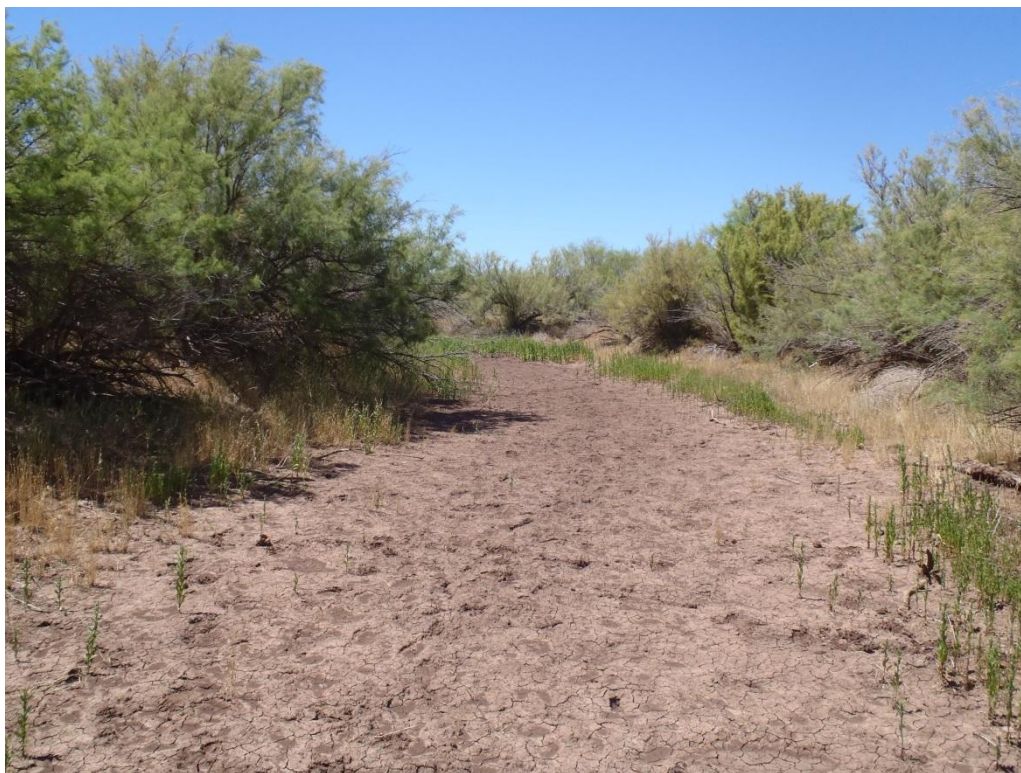
Figure 4.37 Photograph of PD012 taken June 10, 2013. Downstream view of the 150-m transect. Note the lack of water, shrub dominated banks and animal tracks in the creek bed.

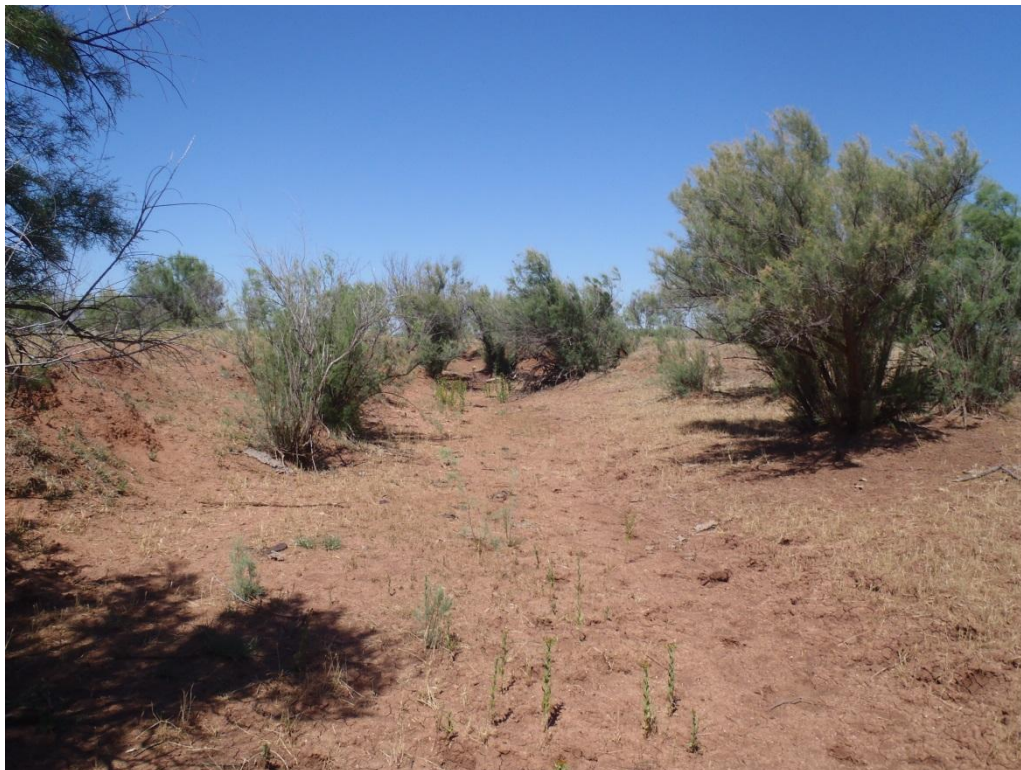
Figure 4.38 Photograph of PD013 taken June 10, 2013. Upstream view at the 150-m transect. Note the minimal brush, livestock tracks and lack of water.

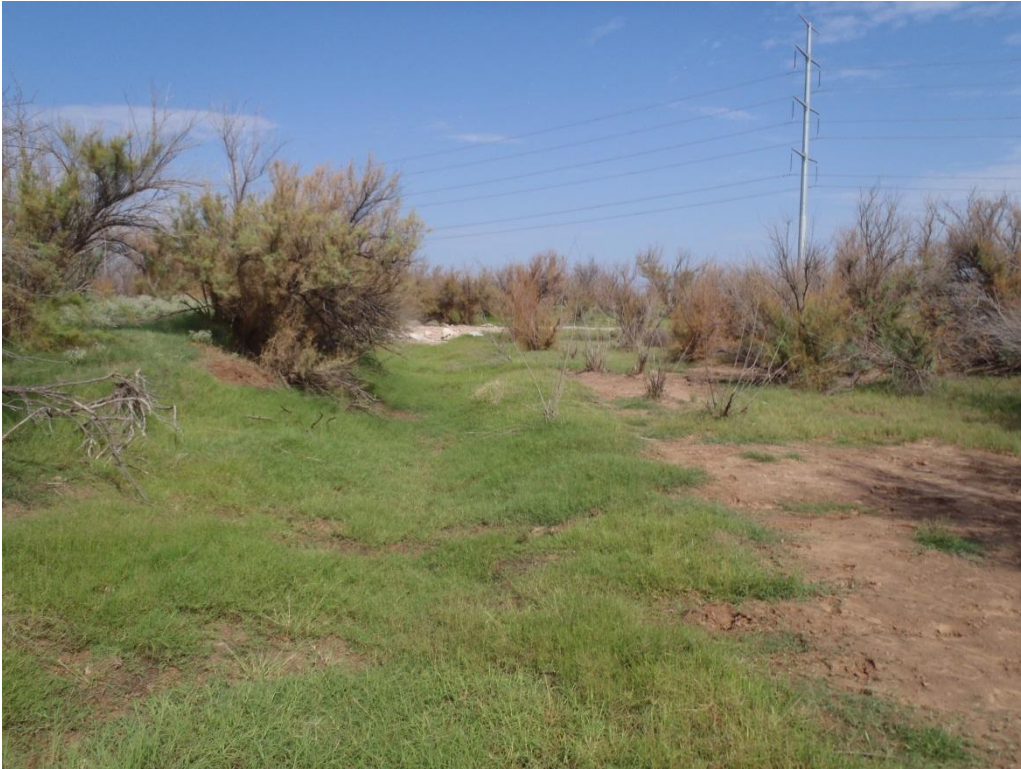
Figure 4.40 Photograph of PD014 taken August 12, 2013. Upstream view of the 150-m transect. Note open corridor with minimal brush and transmission line right of way bisecting the creek

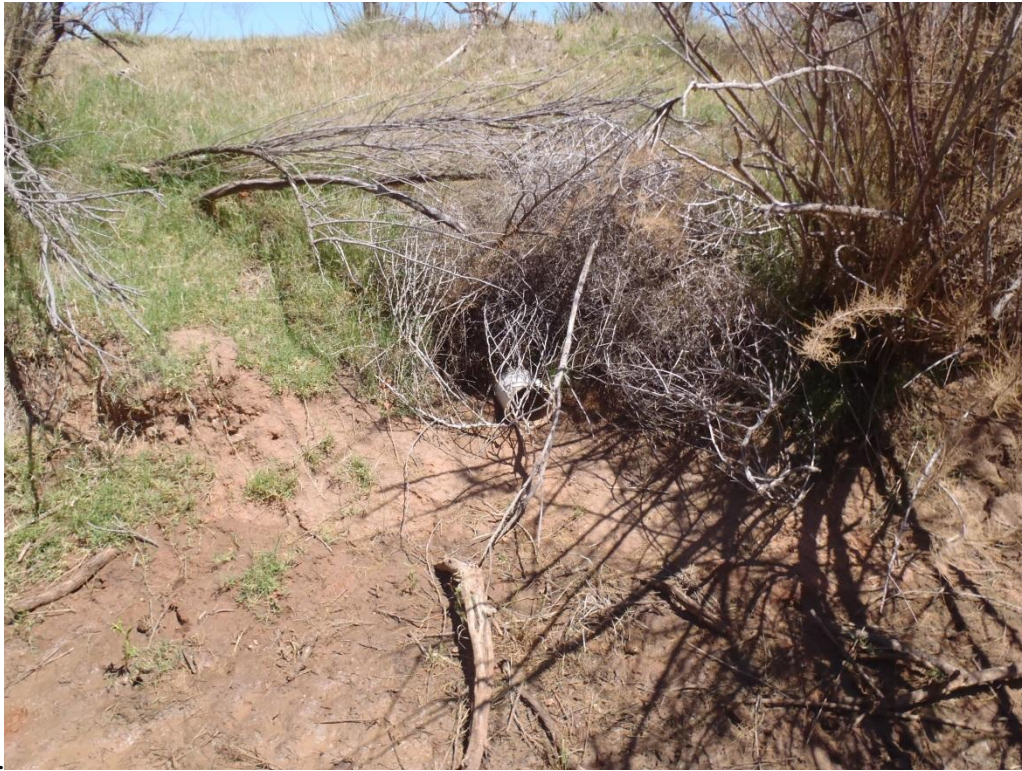
Figure 4.41 Photograph of PD014 taken June 10, 2013 of a tile drain at the 120-m transect.

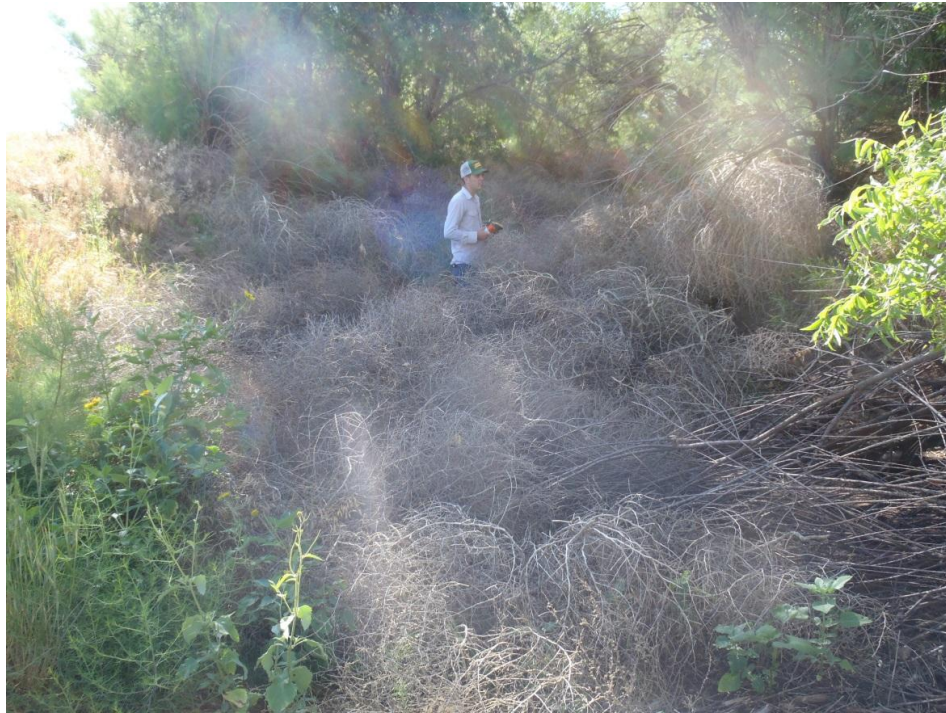
Figure 4.44 Photograph of PD016 taken June 10, 2013 of accumulation of tumbleweeds in the channel. TIAER personnel in photograph.

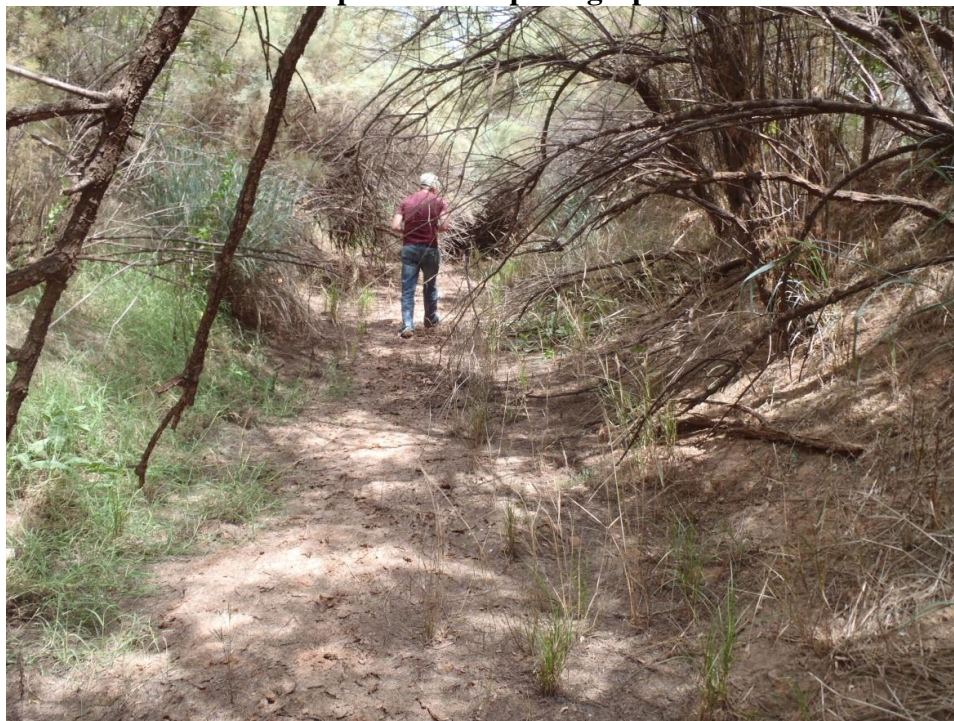
Figure 4.45 Photograph of PD016 taken August 11, 2013. Downstream view at the 150-m transect. Note densely vegetated banks, lack of water and grass in the channel. TIAER personnel in photograph.

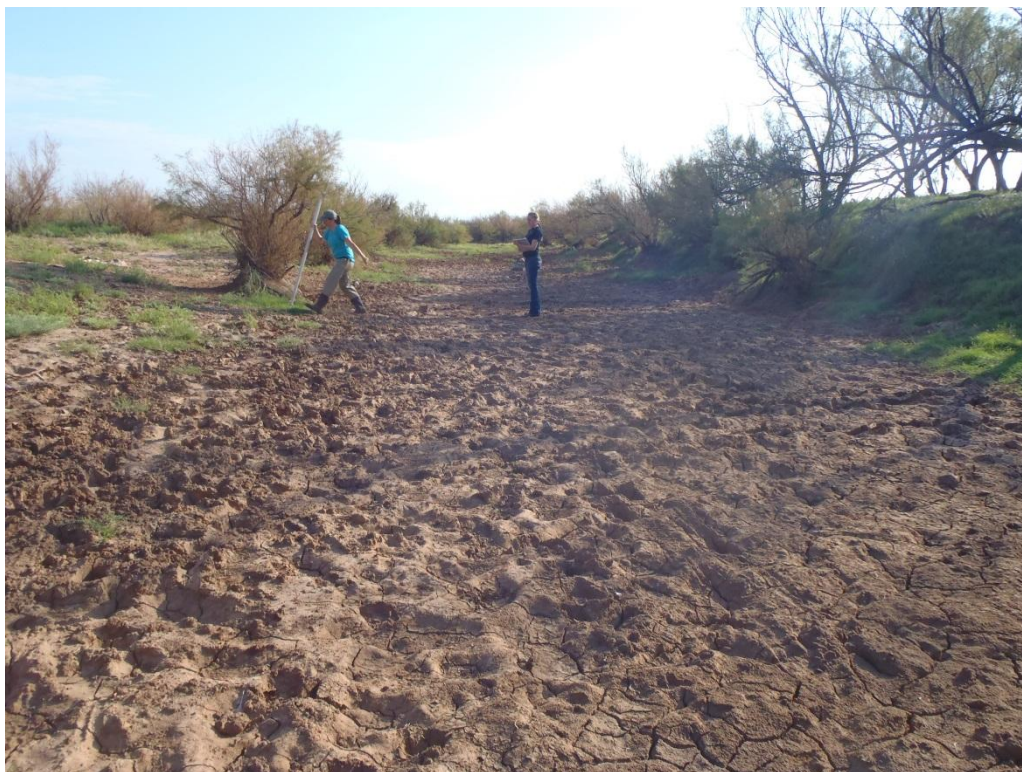
The primary substrate was sand in some places and clay/mud under the bridge where water was standing during the first survey (Table 4.5). The corridor was dominated by improved pasture however some brush existed in the stream bed (Figure 4.47). Where water was present, the surface was free of any scum or algae and the color was slightly brown but the bottom sediment was visible.

Figure 4.47 Photograph of PD017 taken August 13, 2013. Downstream view at the 300-m transect. Note lack of water, pasture at the top of the banks with some shrubs on the bank and in the channel. TIAER personnel in photograph.

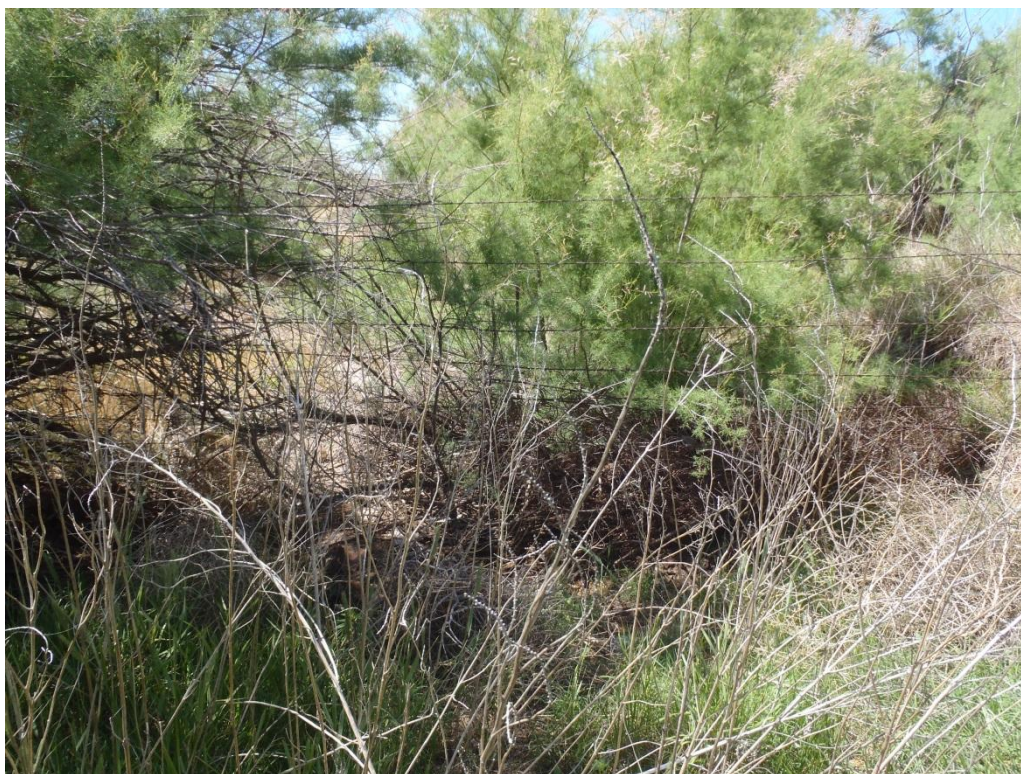
Figure 4.50 Photograph of PD018 taken June 9, 2013. Downstream view at the 300-m transect taken from the county road crossing. Note the private property barbed wire fence limiting public access.

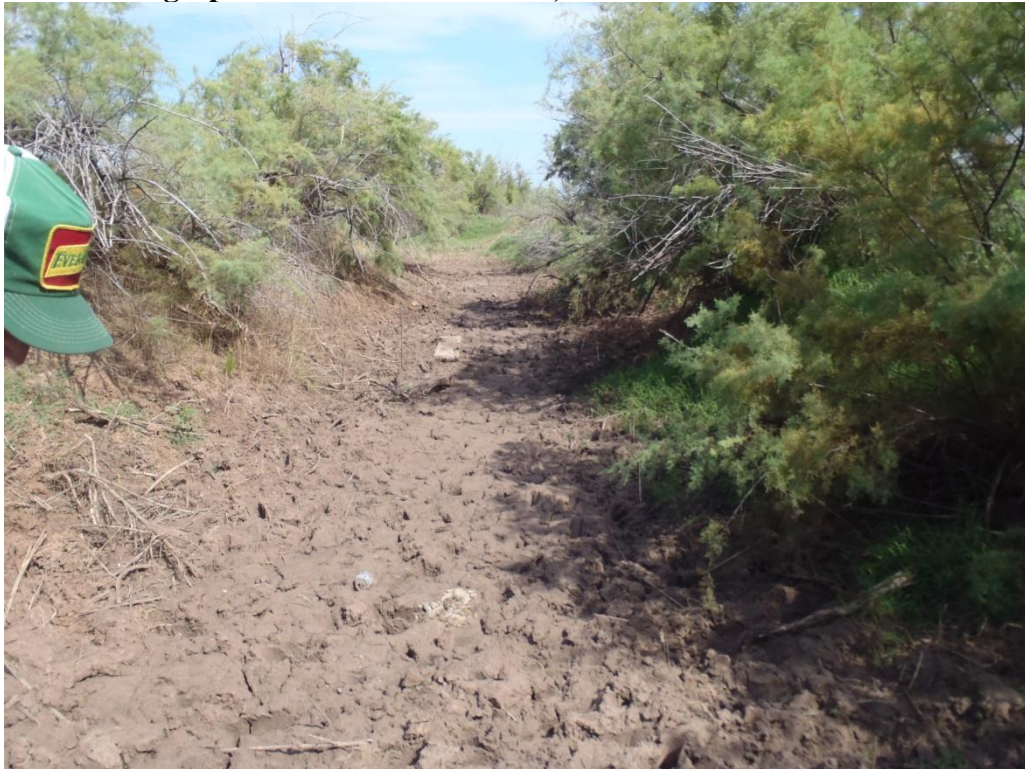
This segment of Paradise Creek was dry with an average thalweg of 0.00 m during both surveys (Tables 4.6, 4.7 and 4.8). No water was observed in the stream nor measured. The dominant substrate at this site was clay. The corridor was dominated by dense shrub vegetation on both banks (Table 4.5 and Figure 4.52).

Figure 4.52 Photograph of PD018 taken August 12, 2013. Downstream view at the 300-m transect. Note lack of water, garbage in the stream and shrub dominated corridor. TIAER personnel in photograph.

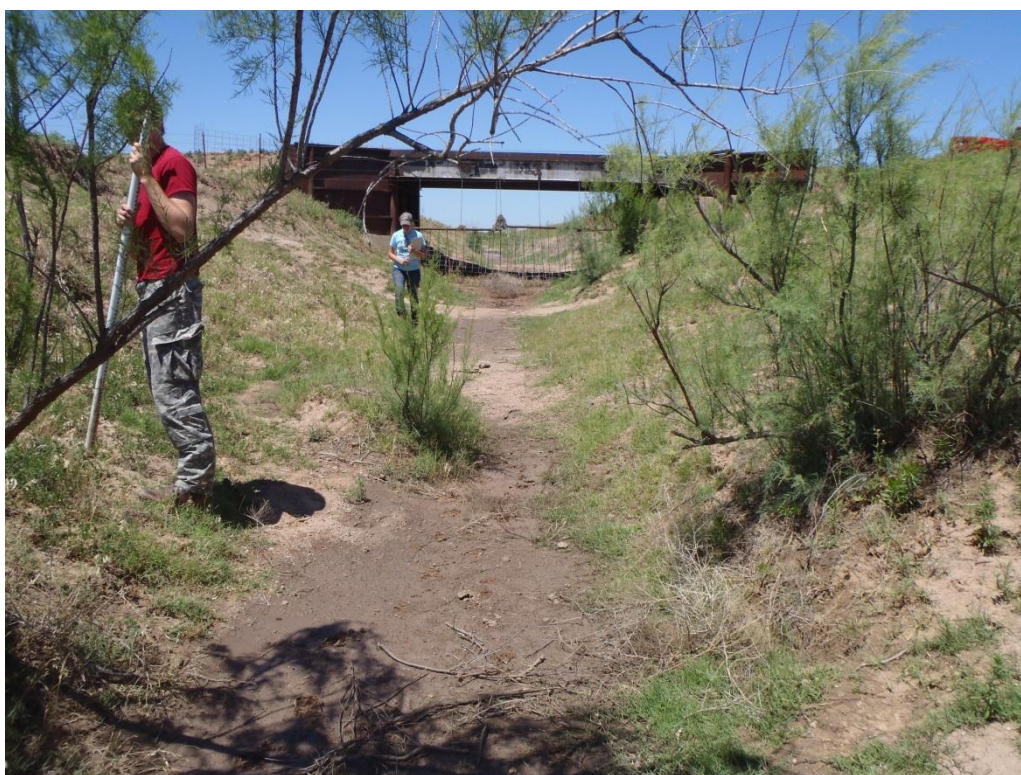
Figure 4.53 Photograph of PD020 taken June 10, 2013. Upstream view at 300-m transect. Note limited public access point. TIAER personnel in photograph.
